St John the Baptist – Barnby

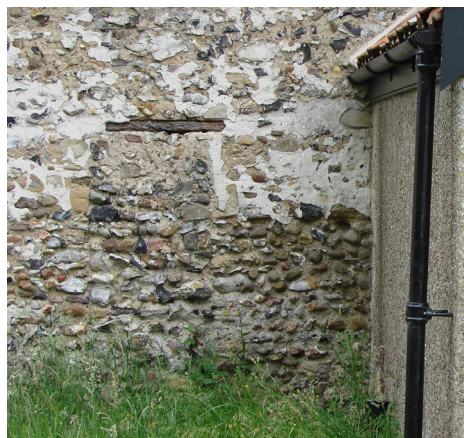
The original north door with its oak lintel

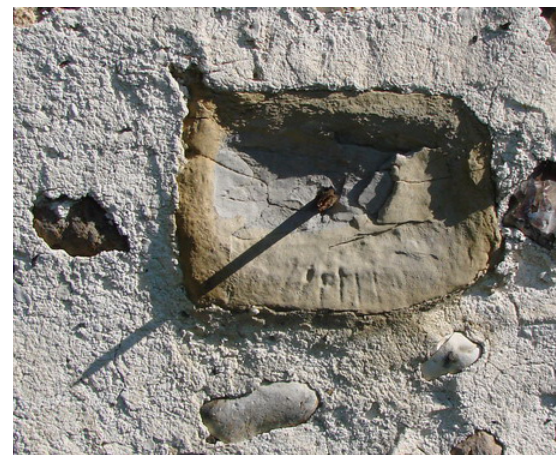
The scratch dial adjacent to the original south door, at 9 a.m. near midsummer

The remains of a scratch-dial (a “sun dial” to tell worshippers the times of services) can be seen in the middle of the south wall. It was located on the eastern jamb of the original doorway before the nave was extended. Unusually, it has been cut in a piece of soft field-stone, rather than in the more usual material of dressed limestone, presumably because none was available. Faint division marks can still be seen at the bottom of the “dial”.

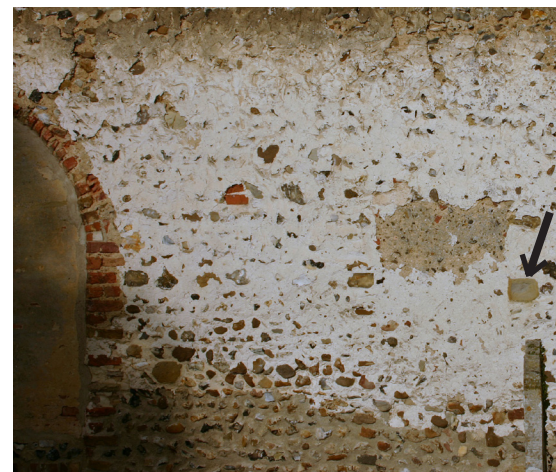
*The two blocked doors in the south wall.
The scratch dial is arrowed.*

The later south door has also been blocked for centuries. It has always been assumed that this happened after the part of the village to the south of the church disappeared. In 1999, members of the Local History Group discovered evidence of two house sites in the field to the south-east, with pottery and metal finds that indicate that the sites were occupied between the 13th and 18th centuries. Since then, all the land round the church has been used as farmland.
